13th AUGUST 1935: A CATASTROPHIC DAM FAILURE IN THE ORBA VALLEY (PIEDMONT, ITALY)

Vittorio Bonaria (1), Giovanni Tosatti (2)

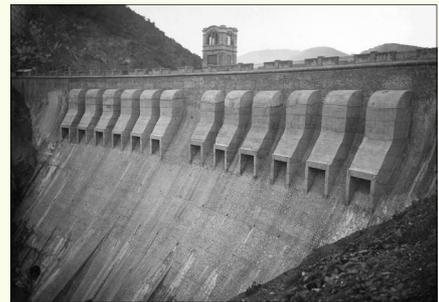
Fig. 2 – The Main Dam of Bric Zerbino showing the twelve dam siphons (O.E.G. photo, 1925)

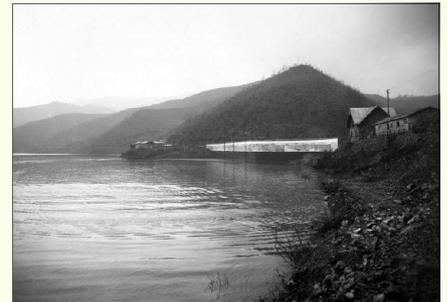
Fig. 3 – The reservoir and Secondary Dam of Sella Zerbino (photo from the mid-1920s)

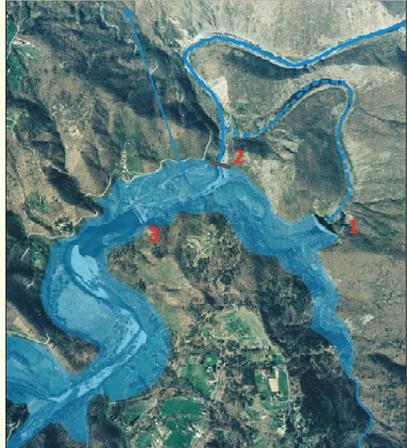
Fig. 4 – View of the maximum impoundment with the position of the two dams (1 and 2) and the check dam of Ortiglieto (3) on the Torrent Orba

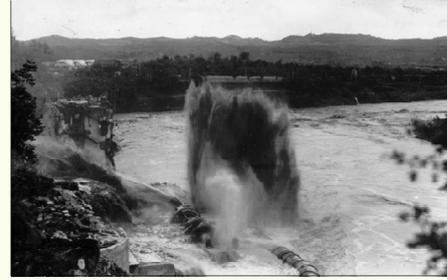
On the morning of 13th August 1935, after nearly ten years of operation, the rock sill on which the Secondary Dam had been constructed collapsed following a heavy rainstorm. The failure caused the sudden emptying of the reservoir (Fig. 5) and a large amount of water poured into the underlying valley, wreaking havoc along the whole course of the Torrent Orba (Fig. 6) as far as its confluence with the River Bormida, some 50 km away, near the town of Alessandria in Piedmont. At least 111 people lost their lives in the disaster. The criminal trial held by the Turin Courts in 1938 returned a verdict of acquittal for the managers of the O.E.G. and the designer of the plant. There were multiple causes which led to the disaster and which can be mainly ascribed to the lack of geological investigations within the hydroelectric plant area. In addition, thorough hydrological and hydraulic studies were not carried out, which could have accurately tested the adequacy of the dam’s discharge system. Finally, the original project was changed several times in order to reduce building costs and increase the volume of water stored without ever considering the proper safety of the plant. The Orba Valley disaster occurred 12 years after the Gleno disaster (356 lives lost) and 28 years before the Vaiont catastrophe (1917 lives lost).

Fig. 5 – Destruction of the hydroelectric plant during the emptying of the penstock (August 1935)

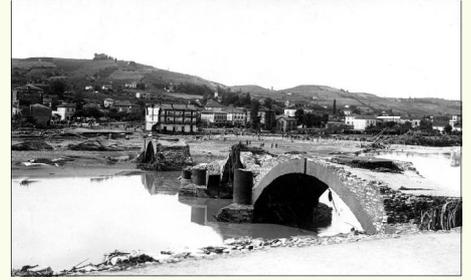
Fig. 6 – Aftermath in the Orba Valley by the village of Ovada (August 1935)
